Manhole Inspection Summary

Manhole # S41MM_005MH

Location Address: **1270 20TH ST**

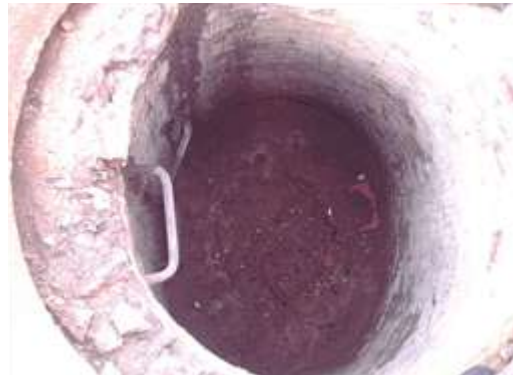
Top View

Corbel and Barrel infiltration. Channel debris.

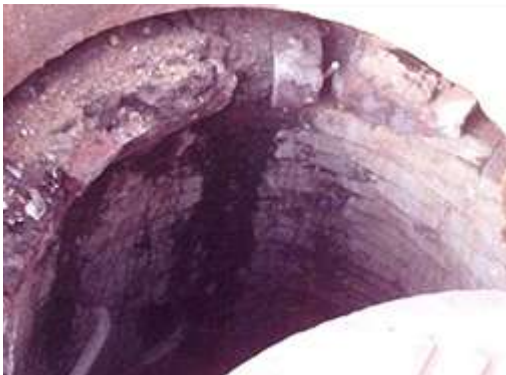
Defect

☒ **Leaks**

Condition: ☐ Sound ☐ Cracked ☐ Root Intrusion ☒ **Loose Brick** ☒ **Deteriorated**

Infiltration: ☐ None ☒ **Joint** ☐ Cracks ☐ Mortar ☐ Roots ☒ **Wall**

Frame leaks. Frame offset. Adjustment deterioration, loose brick and infiltration.

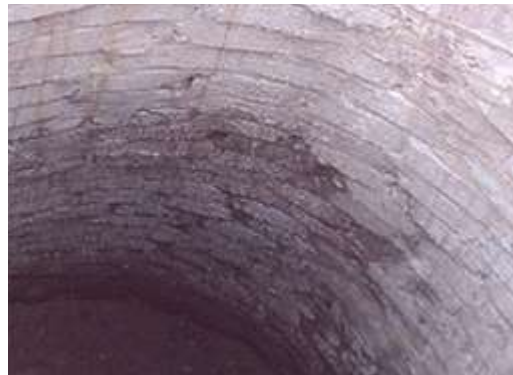
Defect

Infiltration: ☐ None ☐ Joint ☐ Cracks ☐ Mortar ☐ Roots ☒ **Wall**

Barrel infiltration.

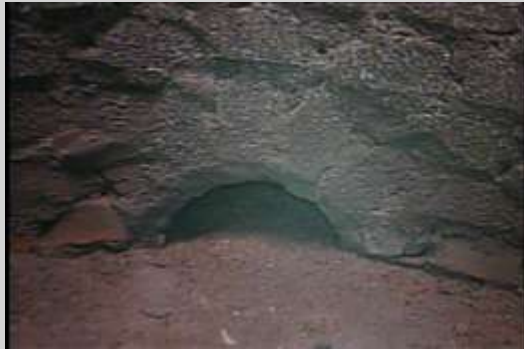
8 in. Circular Gravity Sewer
Pipe Out @ 12 O'Clock

Deposits: ☐ None ☒ **Mud** ☐ Sludge ☐ Debris ☐ Grease

Silt Depth: **5** (in.) Deposits Extent: **Heavy**
